# St. Mary the Virgin

## Aylesbury, Buckinghamshire

The first major phase of works to be considered was the re-leading of the Lady Chapel roof. Fr. Shane Wood, the rector of St. Mary's, was successful in securing a grant for partial funding of these repairs from Buckinghamshire Historic Churches Trust, and Caroe & Partners was appointed to draw up a specification of work and to seek suitable tenders.

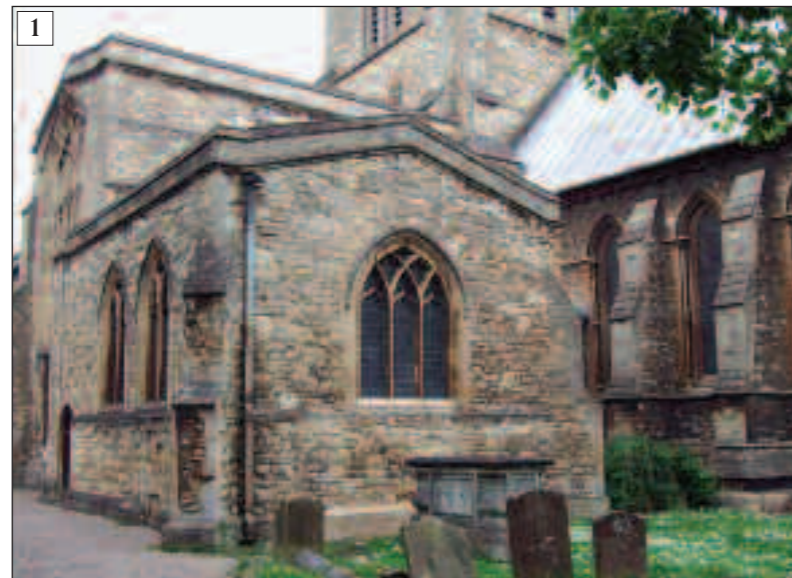
- 1> Lady Chapel prior to the works: view from the south-east
- 2> Interior of the Lady Chapel
- 3> Ceiling of the Lady Chapel
- 4> Leadwork prior to the works: view to the north-east
- 5> Leadwork prior to the works: view to the north-west
- 6-8> Examples of graffiti found on the existing leadwork

Lady Chapel to the south-east, built during the fourteenth century [1, 2]. Further enlargements and modifications were made in the fifteenth century, and in the seventeenth century, a clock and spirelet were added above the existing tower. The church was extensively restored during the eighteenth century and was Grade I listed in 1952. The church continues to play an important role in the spiritual, community and cultural life of the town, and maintains various facilities, including an office and a large kitchen, as well as a small café and toilets, for the use of visitors.

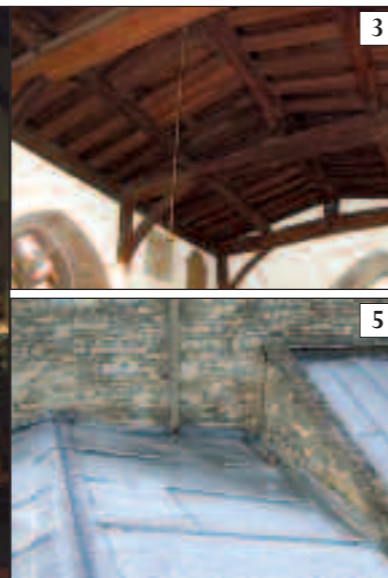
The structure of the chapel roof comprises a series of timber trusses, with posts supporting the ridge beam and purlins; close-spaced rafters span between these to support a boarded roof [3]. The roof of the chapel is of shallow pitch, and was covered in lead sheet of irregular widths, draining to gutters concealed behind stone parapets on the north and south elevations [4, 5].

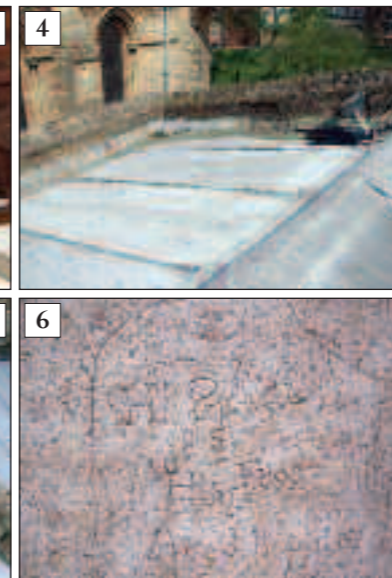
interesting insight into those who may previously have been on the roof, and perhaps also the names of the lead plumbers who laid the original coverings. After a service life of over 250 years, however, the leadwork was found to be in a poor state of repair, with slumped bays, numerous pits and scratches, as well as patch repairs of various kinds.

To the pitched roof slopes, therefore, instead of a single lead sheet from ridge to gutter, two sheets were used, with a long lap to achieve the required vertical coverage and to prevent water ingress via capillary action. Similarly, the bays were made narrower to conform with current requirements for thermal expansion and regularised in width to minimise wastage.

Given the poor condition of the lead, and in order to conserve the fabric of the Lady Chapel for the long-term, it was decided, in consultation with the client and the DAC, that the most suitable form of repair would be complete re-leading. This, however, presented various challenges in terms of the design

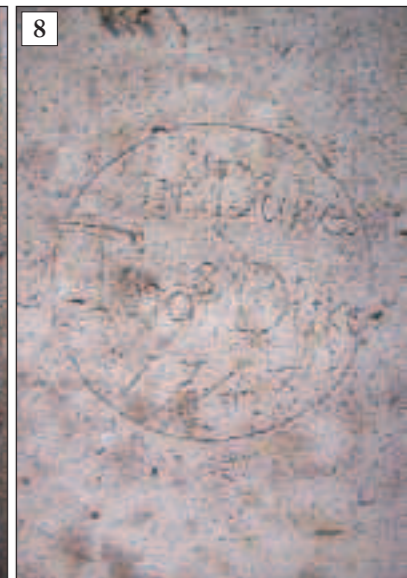
During an initial inspection of the roof, various inscriptions were found in the leadwork, particularly on the more sheltered north slope. These dated back to the mid-eighteenth century, and included one which reads, "H. Pricketts / 1815 / His Foot / Aged 11 years," incised within what appeared to be the outline of a small shoe [6]. Others record the names of "John Wheeler / Isaac Wheeler / George Duke / 1743," neatly written within a precisely-drawn circle [7]; and Jno [John] Duke / Thos [Thomas] Duke / 1748," similarly circumscribed [8]. These inscriptions give an

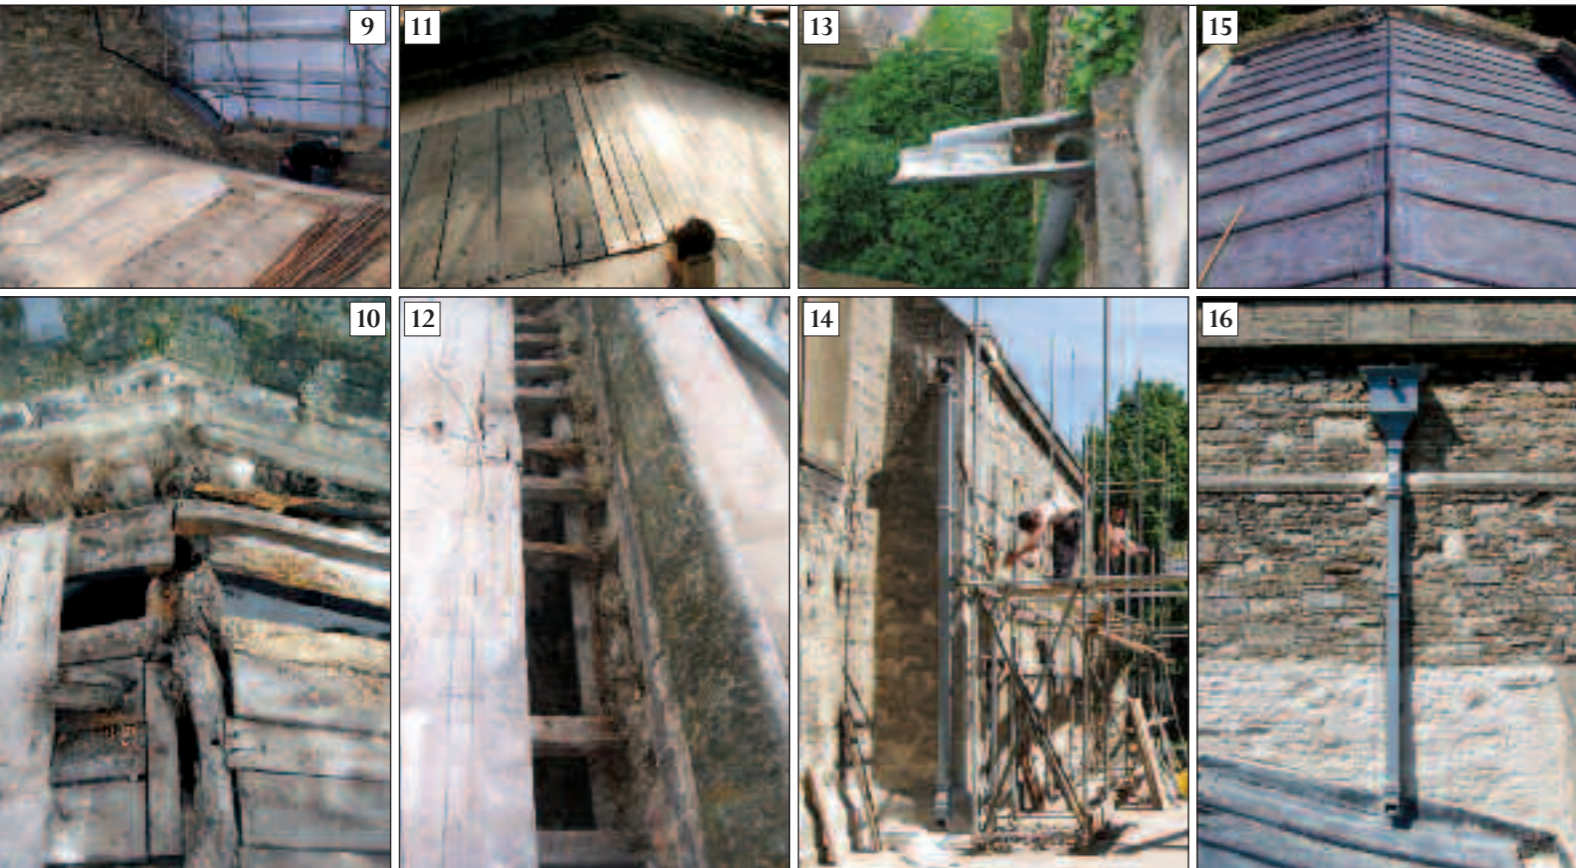
- 9> Existing boarding following removal of the lead
- 10> Decayed ridge beam and rafters to the east end of the chapel
- 11> New timber boarding replaced following repairs to the structure at the east end
- 12> Existing gutter bearers to the south of the roof
- 13> Existing lead overflow chute to the north elevation
- 14> New lead overflow chute and downpipe to the south-west corner
- 15> New leadwork to the roof
- 16> Redecorated rainwater goods and sheltercoated stonework to the west of the chapel

As the leadwork was removed, samples of the graffiti were carefully cut out and handed to the client for safekeeping. The timber boarding that was revealed beneath the leadwork formed an undulating surface that had been repaired in various places, but was generally found to be in a reasonable state of repair [9]. Some small areas of boarding were replaced or re-fixed to remove significant steps; but in general, the surface was retained.

Of greater concern was the east end of the ridge beam, which was found to be partially decayed, and appeared to provide little support to some of the adjacent rafters [10]. The structural engineer Clive Haywood was appointed to carry out an inspection of these members, and advised that although there was some loss of material, the spans were relatively short, so only minor strapping would be required. These repairs were carried out, along with other works to secure the ends of the rafters, to isolate timbers from the masonry where possible, to make repairs to the wall, to replace defective boarding [11], and to provide a timber fillet for the leadwork at the junction with the masonry.

While timber to the roof slopes was retained as far as possible, the existing gutters were removed in their entirety and reconstructed to new levels [12]. Proposed modifications to the south gutter were found to be feasible, and an outlet was provided through the buttress at the west end, incorporating a new lead overflow chute to match those elsewhere on the chapel [13, 14]. New timber rolls were provided to the whole roof surface, and the leadwork laid in accordance with the specification [15].

Repairs to the parapet walls involved the replacement of several coping stones, and, following analysis of the existing stone, a Bath Stone from Hartham Park quarry was found to provide a good match. Other plastic repairs were carried out to the stonework using a lime mortar, and a lime sheltercoat was applied to the friable stonework at the west end of the roof [16], all colour-matched to the existing stonework.

The rainwater goods, which consisted of lead overflow chutes and cast-iron downpipes were generally removed, overhauled, redecorated and fixed back in position. The gullies to the east of the chapel, however, they were found to be blocked solid, causing the downpipes to block up and eventually split at low level. These lower sections were therefore replaced, and the gullies cleared.
