### Churchyard Fives - An Advisory Note

Recent survey work in central Somerset has identified a number of physical adaptations of the exterior fabric of parish churches which appear to be associated with attempts by the post-medieval church authorities to prevent or accommodate the playing of fives against their buildings. Some of these have been noted in the past, but a more painstaking examination of the fabric of a sample of churches suggests that the extent of the evidence is much greater than had previously been thought.

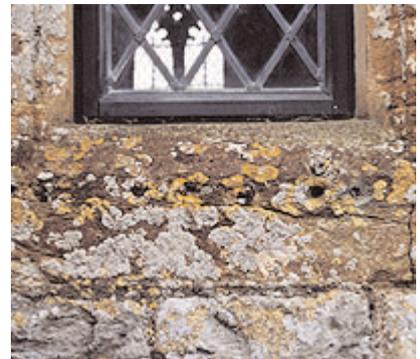
2.2. Lattices fixed directly to the window jambs: similar to more modern lattices designed to protect stained glass, these were held in position with iron hooks or bent-over nails driven into a series of wooden dowels fixed in drilled holes around the jambs (and sometimes also the mullions). The iron fixings are sometimes set in white lime mortar, and are often driven directly into bed joints. The positions of fixings may not match on the two jambs; they should be present in the head of the window, and may also occur on the window sills (though sills are likely to have been renewed in the nineteenth or twentieth century).

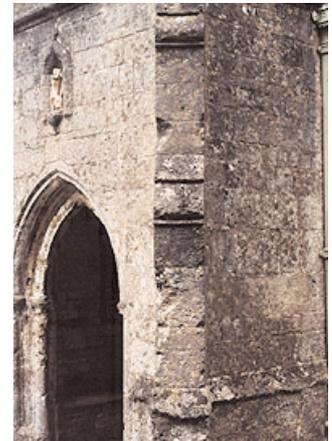
4.2. The adaptation of buttresses by cutting footholds in their outer corners seems to have been the commonest method of getting up to the roof. Easily ignored or confused with accidental damage, these footholds generally take the form of a series of fairly shallow triangular recesses, alternating left and right, which may have been modified (or erased) in several ways

- their lower edges trimmed. When first made footholds would have been most effective if the bottom corner of an ashlar was cut out at the angle, but usually the top corner of the stone below is also cut away - possibly as a result of an attempt by the churchwardens to prevent the players gaining access to the leads. This may explain why it is often the case that more than one buttress has been adapted.

- small inset repairs. Probably after the fives place fell out of use the damage to the buttress may have been repaired by cutting out the foothold to provide the seating for a rectangular whole-stone repair. The position of such repairs will, of course, follow the left-right succession of the original footholds

- chamfering off. Either in an attempt to stop the players climbing, or, after the game had died out, to tidy up the appearance of the buttress, the whole height of the edges may have been chamfered back to remove the footholds altogether.

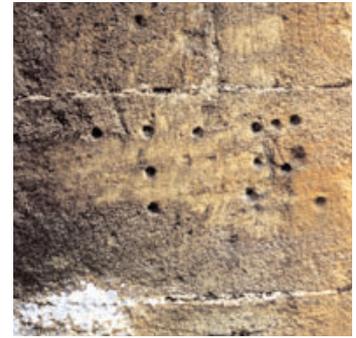
Identified at Martock by Prebendary Saunders (1923) these may take the form of a series of five drilled holes in a cross or 'T' pattern with a sixth outlier. Saunders proposed that they were for counting the five services, the sixth hole serving to mark 'game ball', the 21st point.

At Montacute a lightly scratched grid exists at the base of the buttress immediately east of the fives place. More examples are needed before a definite association with scoring the game of fives is possible.

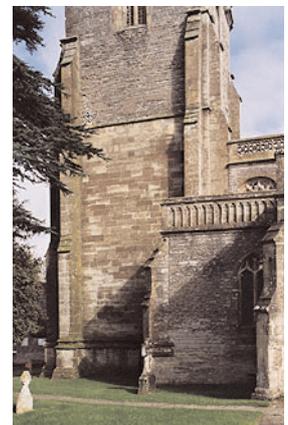
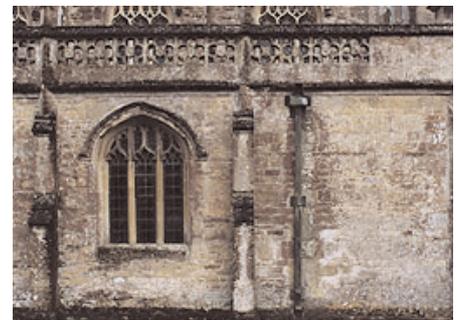
- refacing the fives wall: this is known to have occurred at W Pennard in 1813, where the lower part of the blue lias south wall of the tower was refaced with Doulling stone, and may have been done at Knowston (Devon) and Wookey

- removing obstacles to play: at Montacute two of the original late medieval quatrefoil bands have been trimmed off the southern elevation of the tower; at Closworth the original niche on the north elevation has been cut back flush with the wall and filled

- in the absence of documentary evidence it is impossible to prove that the blocking up of windows is connected with fives play, and often there are other more likely explanations (e.g. Compton Pauncefoot where the blocked west window of the south nave aisle has a monument erected on the interior). However, fives players at several churches have certainly taken advantage of the presence of blocked windows to use the wall as a fives place, sometimes partly refacing the wall.

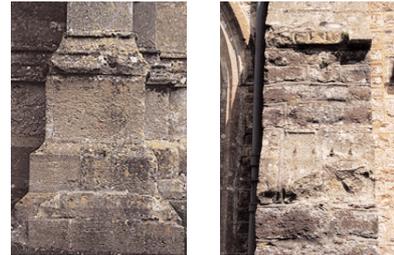
- 8.1. Railings and spikes are known from documentary sources to have been erected to prevent access to the fives place, and the marks left by cutting in the horizontal bars which held the railings are sometimes still apparent in the faces of buttresses.

The drilled holes for spikes on their weatherings show that these were used to stop players using the buttresses to reach the roof to retrieve lost balls.

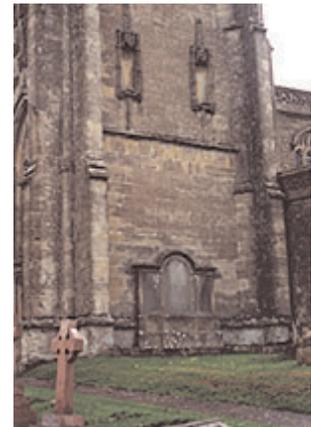
One common means of disrupting the fives place was the setting up of stones, but this seems to have had limited success, probably because the players had the manpower to remove them again. However, at least one determined incumbent provided in his will that he should be buried in the fives place, and the players would have been unable to remove the resultant monument. It seems entirely likely - though without documentary evidence it cannot be proved - that other large monuments erected against the fives wall were inspired by the same motives. Amongst these are the large monument with an extensive rectangular enclosure surrounded by railings built against the south wall of Batcombe tower, and a similar monument in the same position at Ashcott, both of later eighteenth century date.

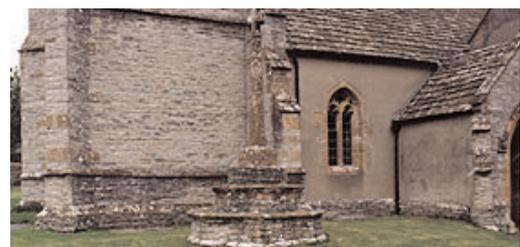
At Ashwick in 1763 the churchyard cross was moved, "to the Vifes place... to prevent the Young People from spending so much idle time in that sort of exercise". The cross at Montacute appears to have been used in the same way in the early nineteenth century, and the proximity of the churchyard cross to the south wall of Charlton Adam tower may have the same cause.
